# CASE STUDY: 2000 Ford F-350 Flatbed with crane

**VEHICLE SECTOR: SERVICE, CONTRACTOR**

**INDUSTRY SECTOR: HVAC**

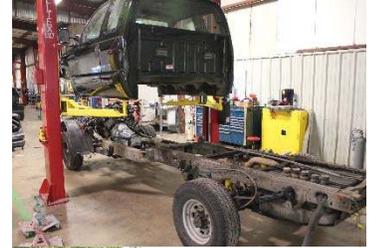
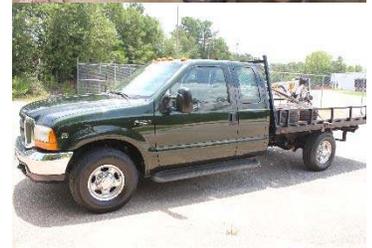
This truck rolled over at 216,000 miles. Worn out and run into the ground – inside and out – it was a great candidate for a reman.

With a rat nest under the intake manifold and decreased power, the engine was ready for a swap. The transmission overdrive was gone – even more reason to get this one reman'd.

Typical for a work truck this age, the suspension and steering subsystem were shot; another need that makes for a great reman candidate.

The ripped driver seat along with some broken and missing interior trim components created a need for some serious attention to the interior.

The exterior was faded and oxidized with more than one good-sized dent and plenty of scratches. The panels were strong and in relatively good shape, so again, this was a great reman candidate.

The remanufactured engine and transmission were coupled to a driveline with new u-joints and carrier bearings. The rear differential was reworked.

Meanwhile, the flatbed was blasted, primed and painted. New decking was installed and the crane was repaired and serviced. New LED lights were installed and the trailer wiring was reworked.

With that going on, the body interior upholstery was replaced along with the broken or missing trim items. The radio and speakers were even replaced too.

The body repair created a good surface for a new paint job. And what a paint job!
